**Phase I and Phase II Targeted Brownfields Site Assessment  
City of Corona  
Corona, CA**

**USACE Contract No.: W912P7-05-F-0049  
Work Order No.: 12767.061.006**

**Prepared for:  
U.S. Environmental Protection Agency  
Region IX**

**Prepared by:  
Weston Solutions, Inc.**

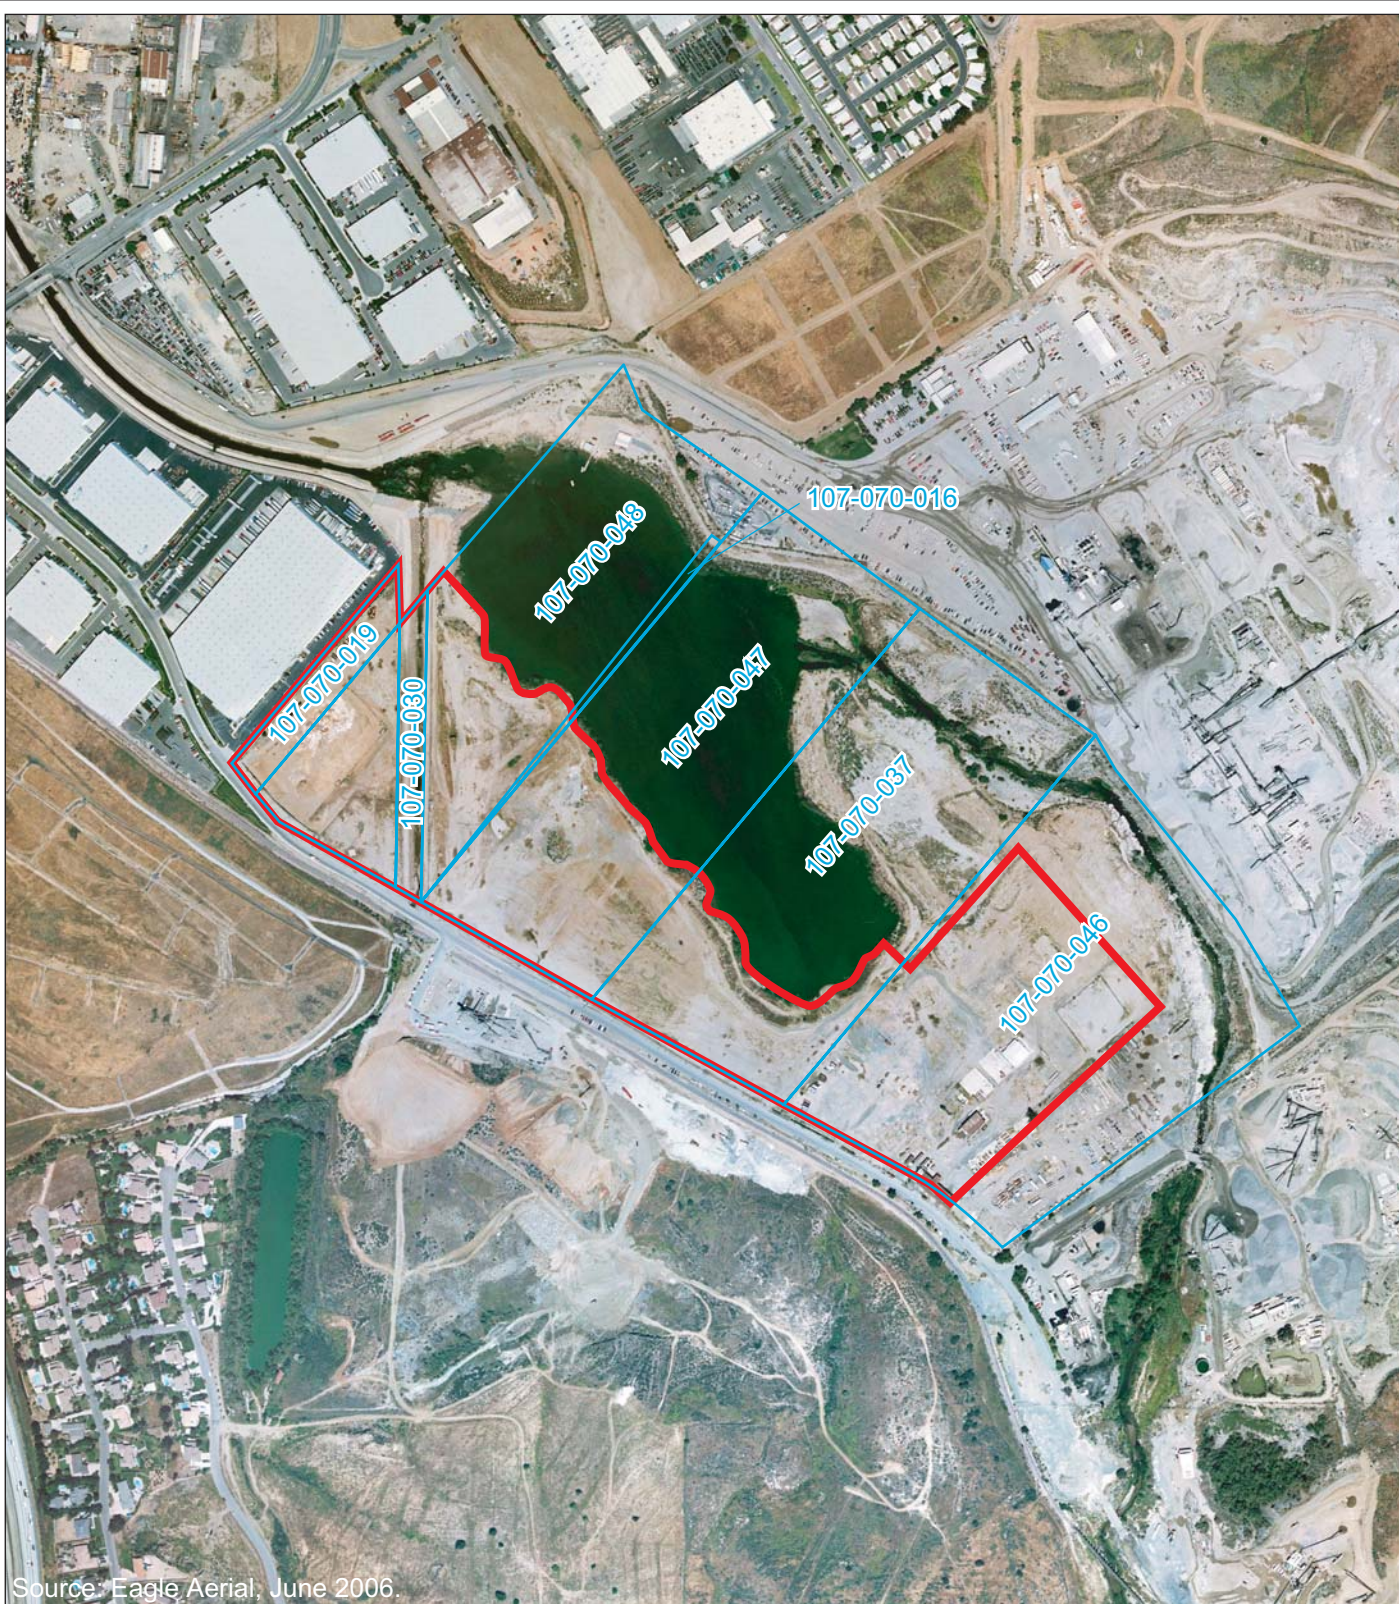
Figure  
**2-2**

The Site lies immediately adjacent to Lake Hohn, which is a pit lake associated with quarrying activities at the site. As shown in Figure 2-2, the areas of the parcels 107-070-016, 107-070-019, 107-070-037, 107-070-046, 107-070-047, 107-070-048 that are occupied by Lake Hohn and to the east of Lake Hohn are not part of the Site. The Site layout is presented in Figure 2-2.

— Site Boundary  
— Parcel Boundary

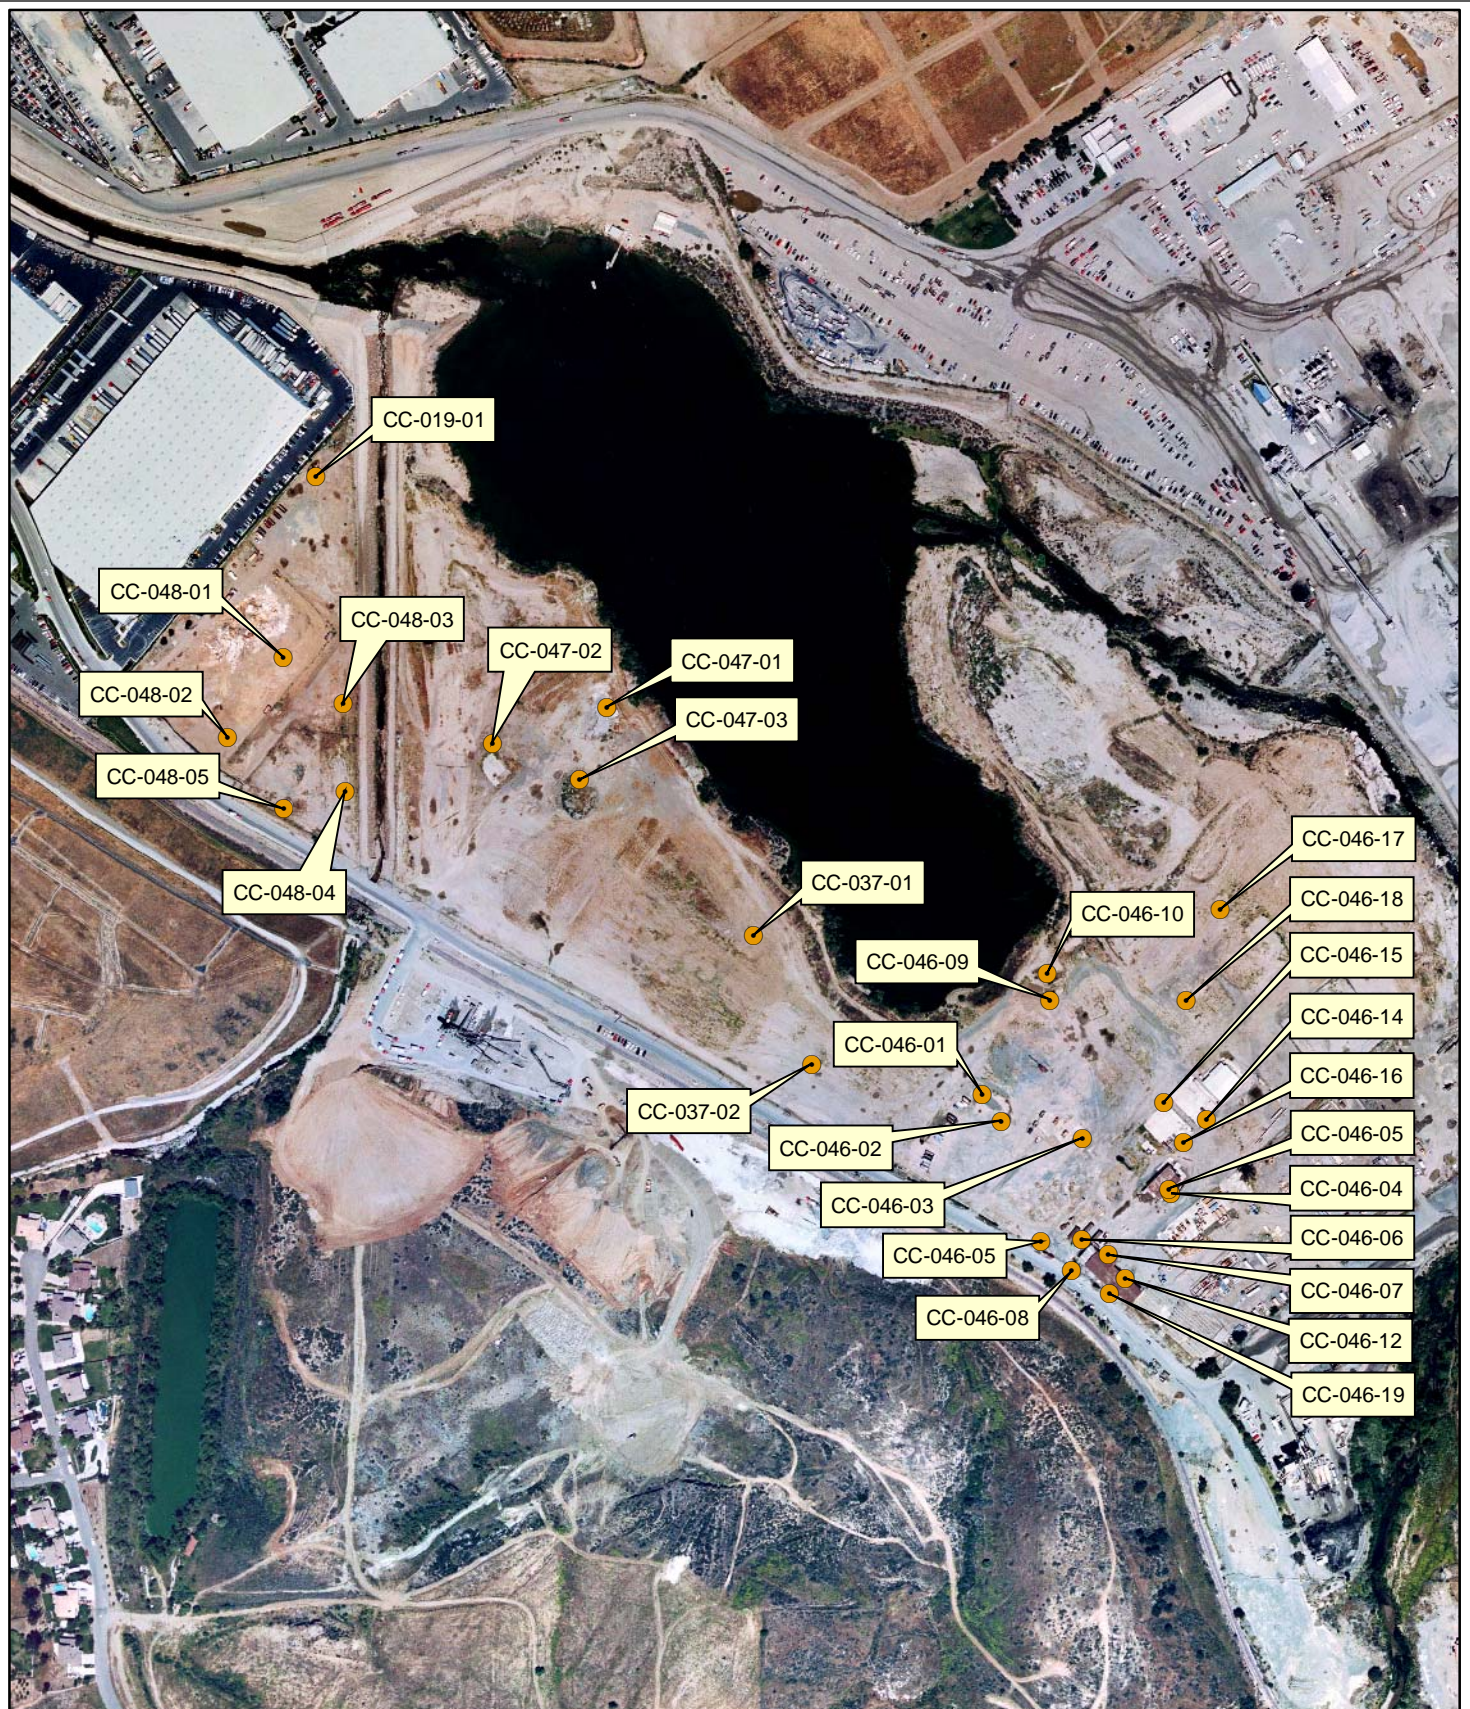
On February 20, 2007 and February 21, 2007, WESTON collected 64 soil samples (58 field samples, 6 field duplicates) from 29 sampling locations at the Site. The predominant soil type at the site is a medium brown sandy soil with varying amounts of silt and gravel. Gravel clasts are predominantly granitoid, and likely derived from the surrounding outcrops.

● Sample Location
